ABATTOIR HERITAGE PRECINCT SYDNEY OLYMPIC PARK

CONSERVATION MANAGEMENT PLAN

Report No. 13012

September 2013

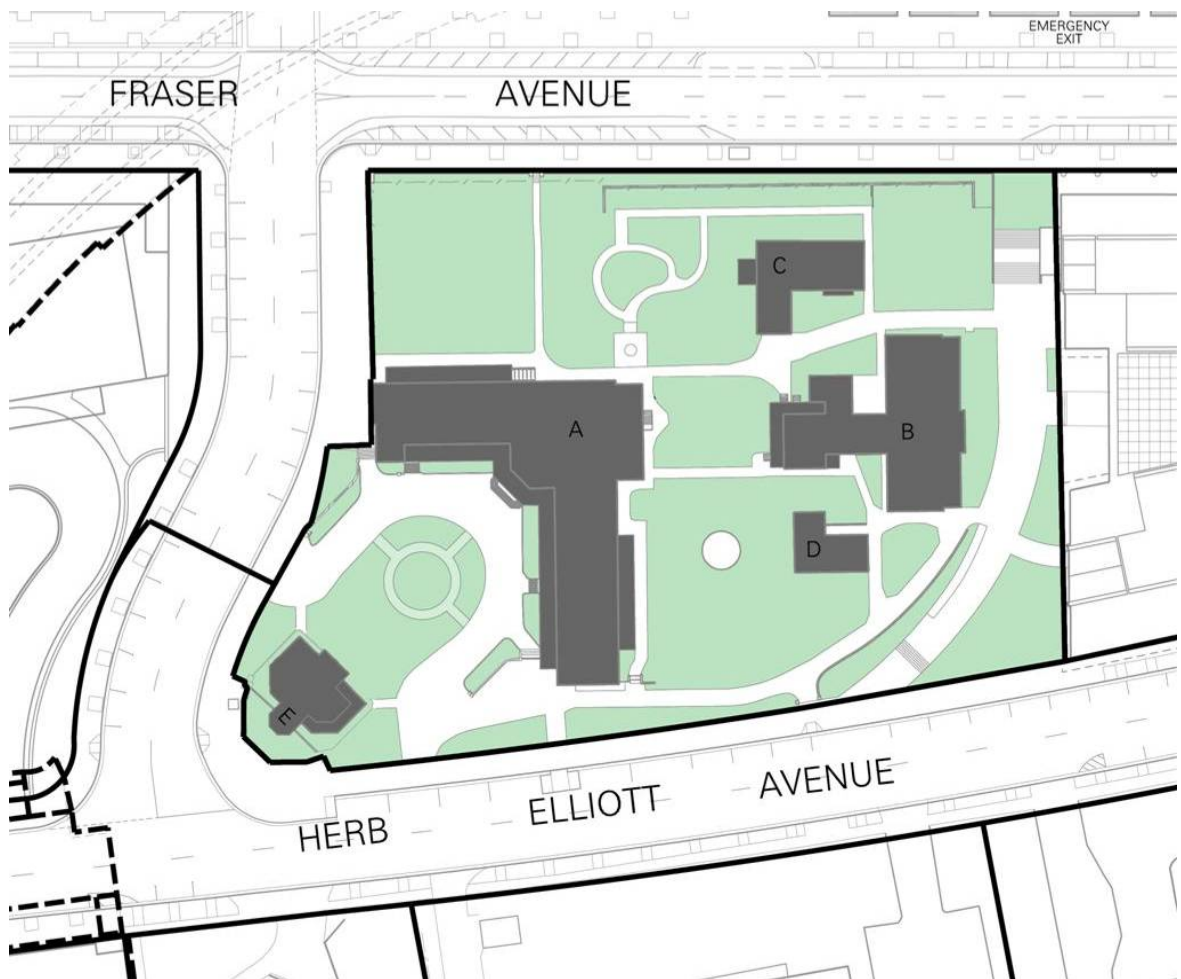
Figure 4
Building numbers

ORIGINAL USE	CURRENT USE	TENANT
Building A	Administration block	Offices	Australian Paralympic Committee
Building B	Staff canteen and refreshment rooms	Offices	Tennis NSW & Rugby League Players Association
Building C	Locker room, lavatories	Café / Bar	Abattoir Blues
Building D	Chemical testing laboratory (or possibly Locker room, lavatories)	Toilet facilities	
Building E	Gatehouse	Visitor Information Centre

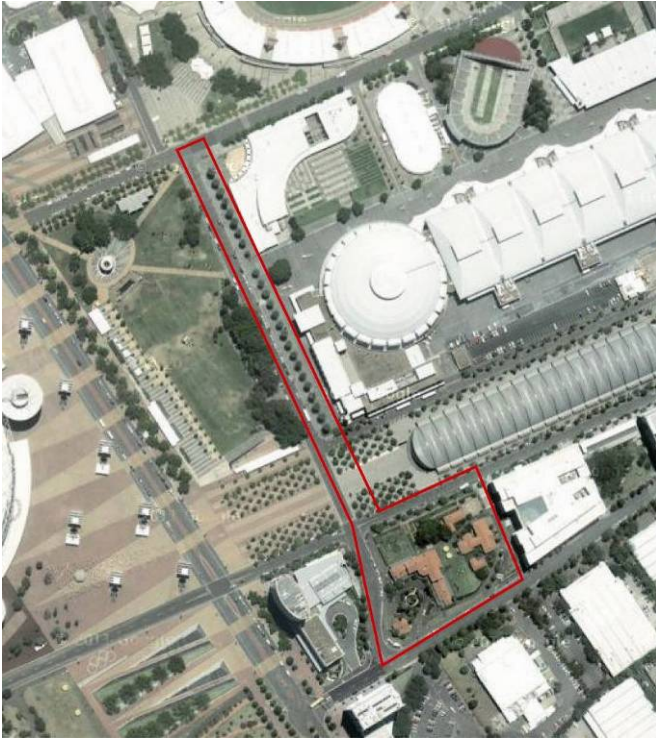
Figure 6
Curtilage of site as identified in 2003 CMP
Source: GAO

In the 2003 CMP, the curtilage of the site included the cluster of building in their gardens as well as a row of large Canary Island Date Palms, lining the eastern side of Showground Road, as some of these palms date from the 1930s. (Refer to Figure 6). However, all of the palms in this area were removed during major ground level changes in preparation for the Games, and subsequently replanted along with many other mature specimens from elsewhere. While some of these trees date from the period of the State Abattoirs, not all of them do and their context and specific location has been radically altered. Similarly, there are a number of other trees across Sydney Olympic Park that date from the State Abattoir period (primarily mature figs that were planted as shade trees in the stockyards), most of which have been relocated to non-original locations.

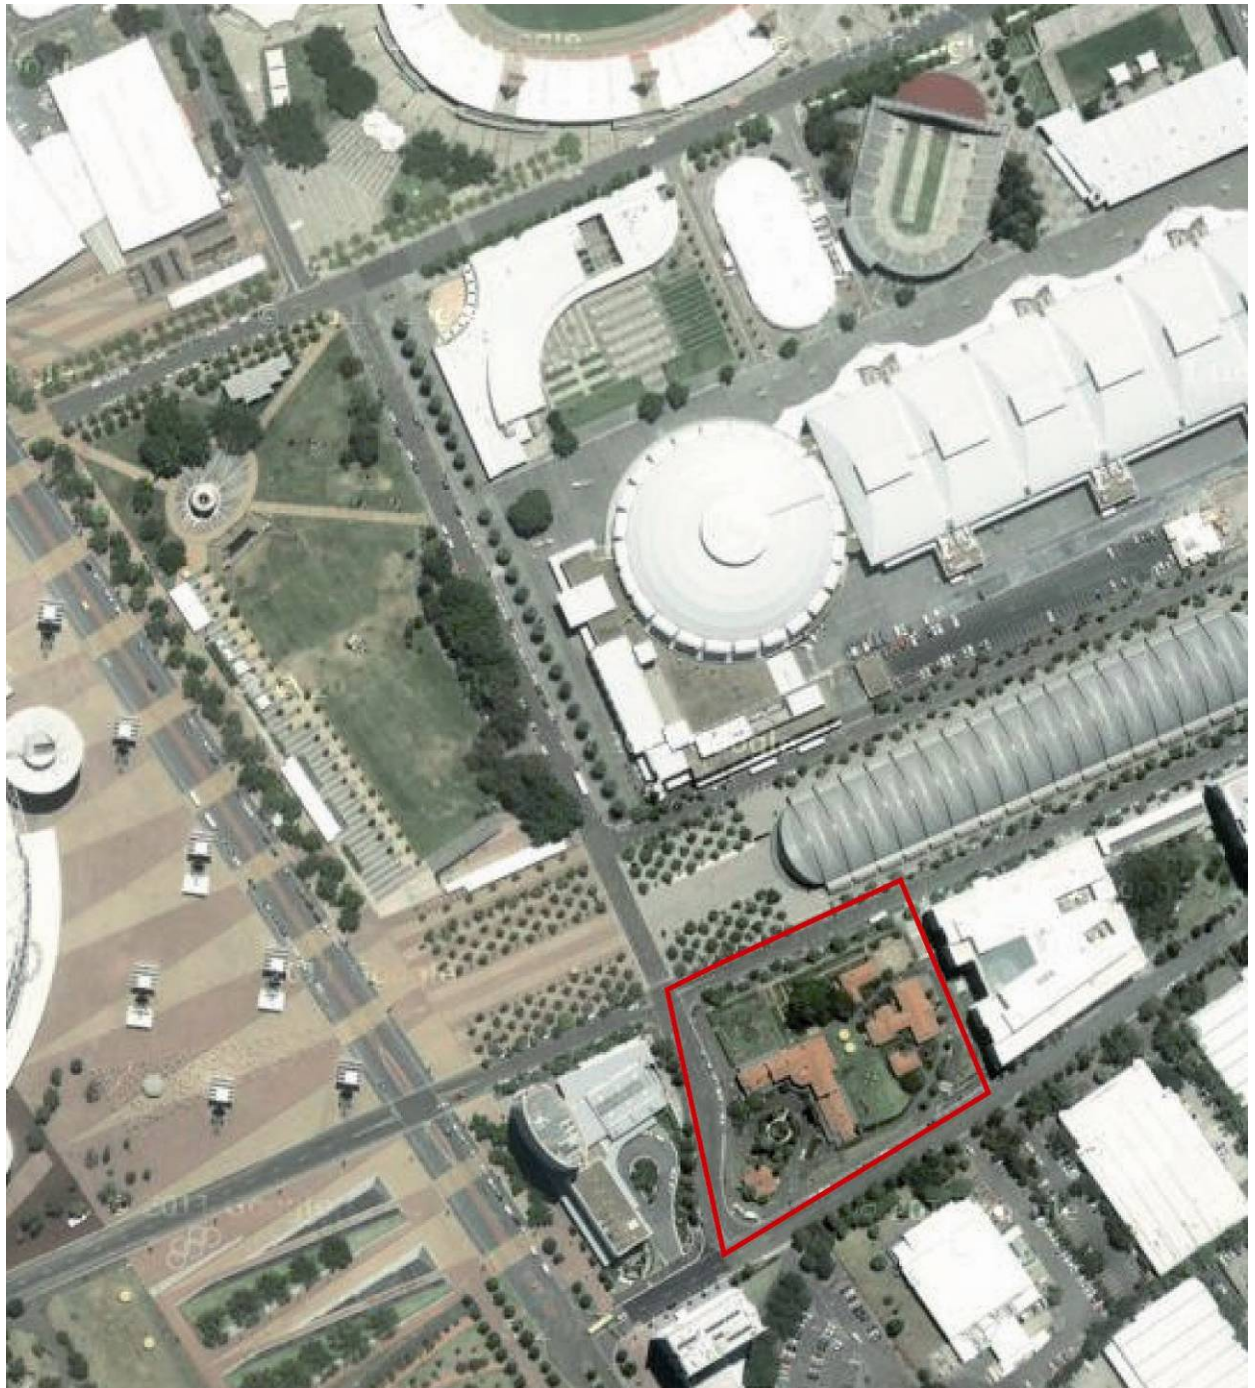
Figure 9
Revised curtilage of site
Source: GAO

As such, the defined curtilage of the precinct should be the site boundary, plus the adjoining roadways. Views to and from the precinct are quite limited due to surrounding buildings and level changes. (Refer to Figure 7)

Adopt the heritage management curtilage for Abattoir Heritage Precinct as shown in Figure 7.

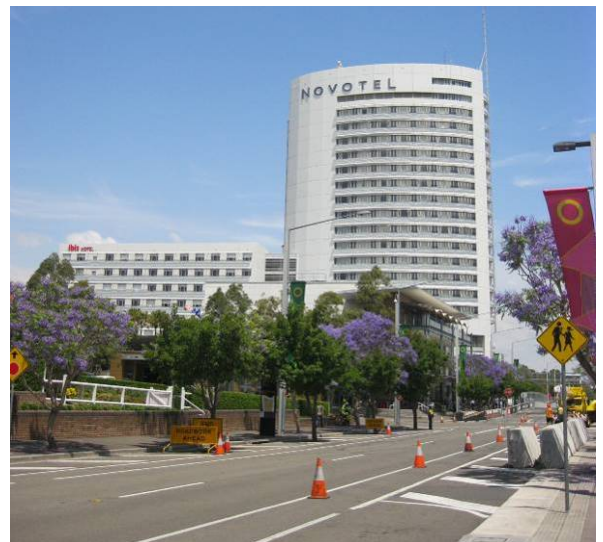
Figure 12
View west along the northern boundary of the site,
showing the retaining wall along the edge of Dawn
Fraser Avenue and looking towards the Hotel Ibis &
the Novotel

Associated with significant levels changes, much of the northern boundary of the site is now a brick retaining wall, increasing in height towards the east. At its highest point, this retaining wall is approximately 4 metres above ground level. As a result, the group of buildings do not make a particularly positive contribution to Dawn Fraser Avenue. However, these retaining walls do help to interpret the previous topography of the Abattoir complex.

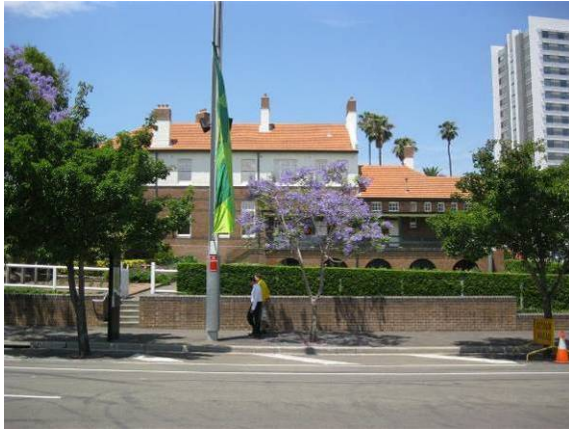
Figure 23
View to Building A from Dawn Fraser Avenue.
Note the retaining wall.

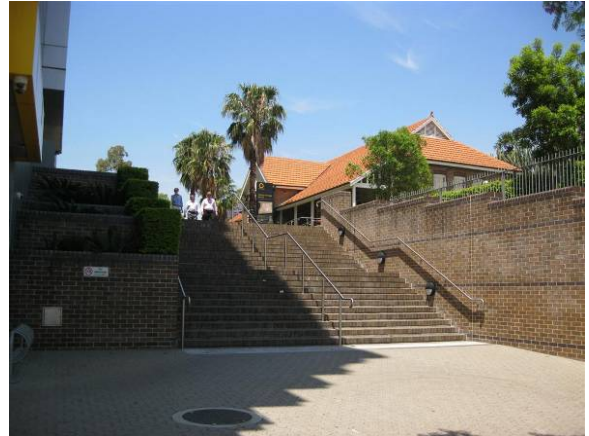
Figure 24
View to Building B along eastern boundary. Note
the retaining wall along the northern edge of the
precinct.

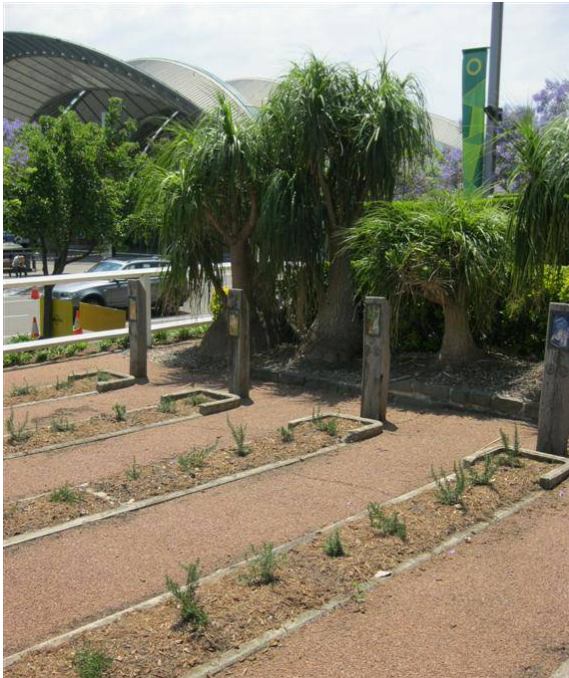
Figure 28
Former drinking troughs

Across the northern edge of this garden, the location of a sheep run has been interpreted using foot prints and paving. Another element of interpretation has been installed in what seems to be former cattle drinking troughs adjacent to the rose garden, with timber and ceramic 'headstones'. These drinking troughs have been relocated from another part of the site, as their current location does not relate to a historic use of this area and they are not visible in this location in 1960s aerial photos.

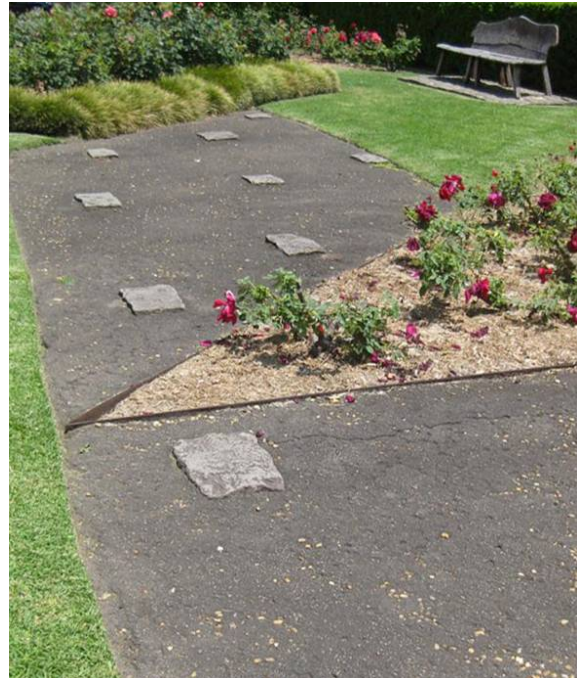
Figure 29
Interpreted sheep run

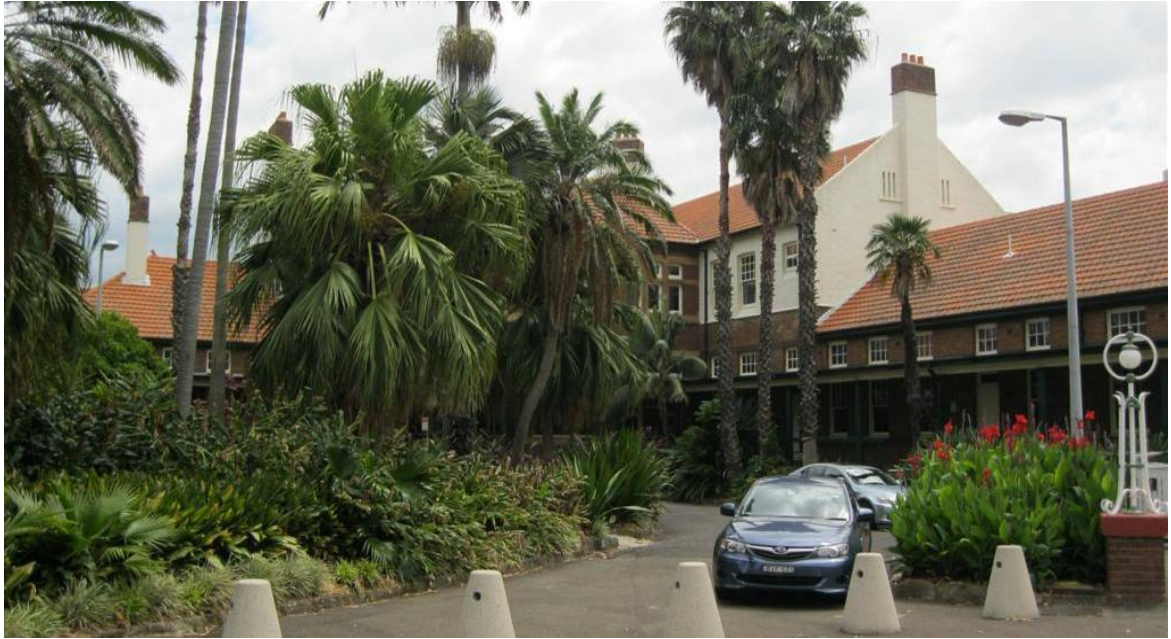
Figure 30
View to Building A, showing carriage loop and palm grove

Between the Gatehouse (Building E) and the main Administration Building (Building A) is a carriage loop, encircling a large palm grove with mature palms (particularly *Washingtonia Robusta*). White gravel paths cross the palm grove. This garden looks very similar to its form and character as it was during the 1940s and 1960s (as evidenced by aerial photos). It is likely that some of these palms are the original planted under instructions from Maiden in the early 20th century.

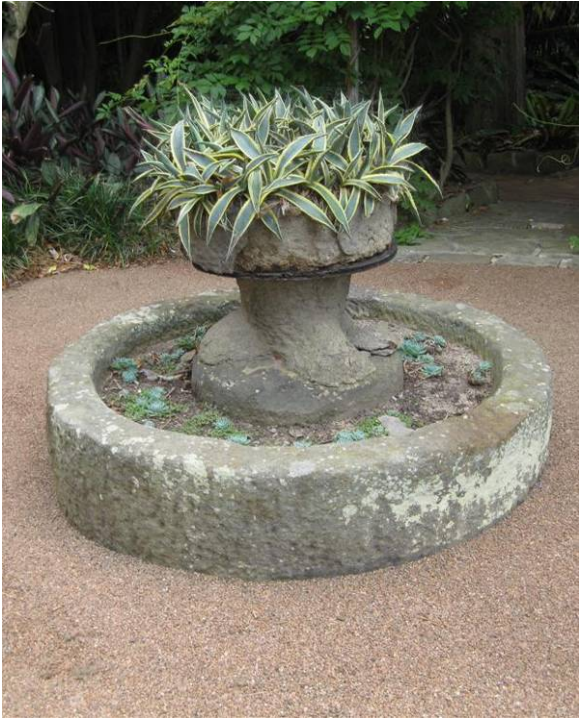
Figure 35
Round garden bed

Near the entry to this area is an interesting round garden bed, with one large bed, with a central pier, supporting another smaller planter. This seems to be made from stone and concrete and is planted with succulents. According to 'Conservation Study, Playfair Memorial Fountain, Homebush' by the Department of Public Works & Services in 1995, this garden bed utilizes an old grinding wheel that predates the abattoirs and may have links to Blaxland, another early land holder in the area, whose estate was adjacent to Home Bush.⁴ There is no specific evidence regarding this provenance.

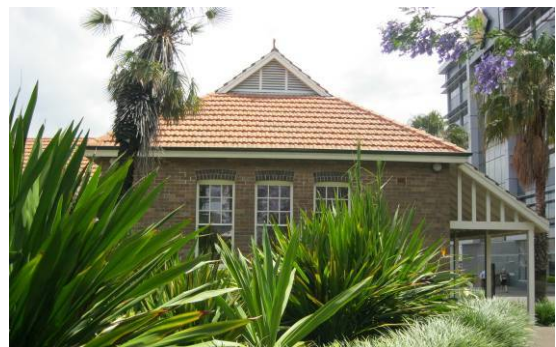
Figure 47
Garden bed south of Building B

Overall, these gardens are in very good condition and are extremely well maintained. They are regularly used by the staff of the adjoining buildings and visitors to the site.

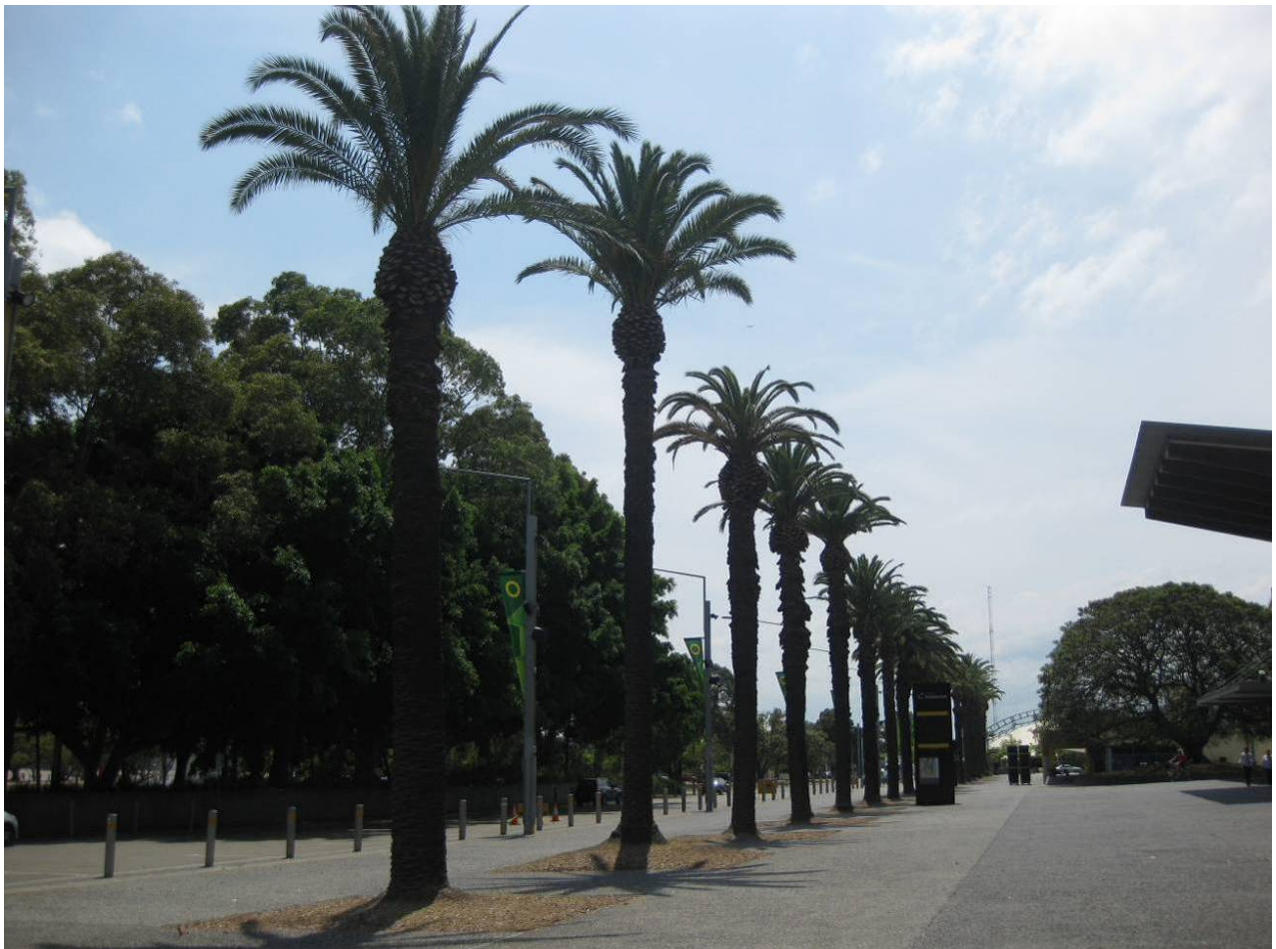
Recent investigations into the health of the avenue of Canary Island Date Palms has identified that they are fast diminishing due to a disease called Fusarium wilt, caused by a fungus, *Fusarium oxysporum*. Symptoms of Fusarium wilt include an unusual type of frond death, leading to the eventual death of the tree. This disease has been the cause of the death of similar trees in Sydney such as Centennial Park and the Royal Botanic Gardens. SOPA intend to remove the avenue within the next few years and replace them with a similar species that has a similar form and shape, but one that is resistant to the Fusarium disease.

Figure 48
Row of Canary Island Date Palms lining Showground Road

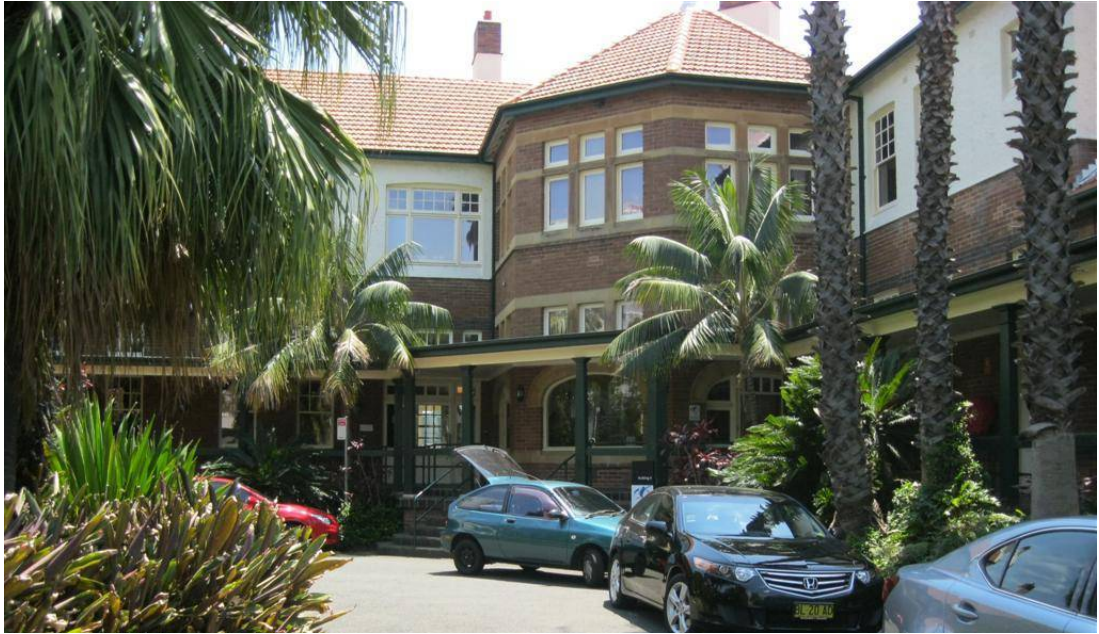
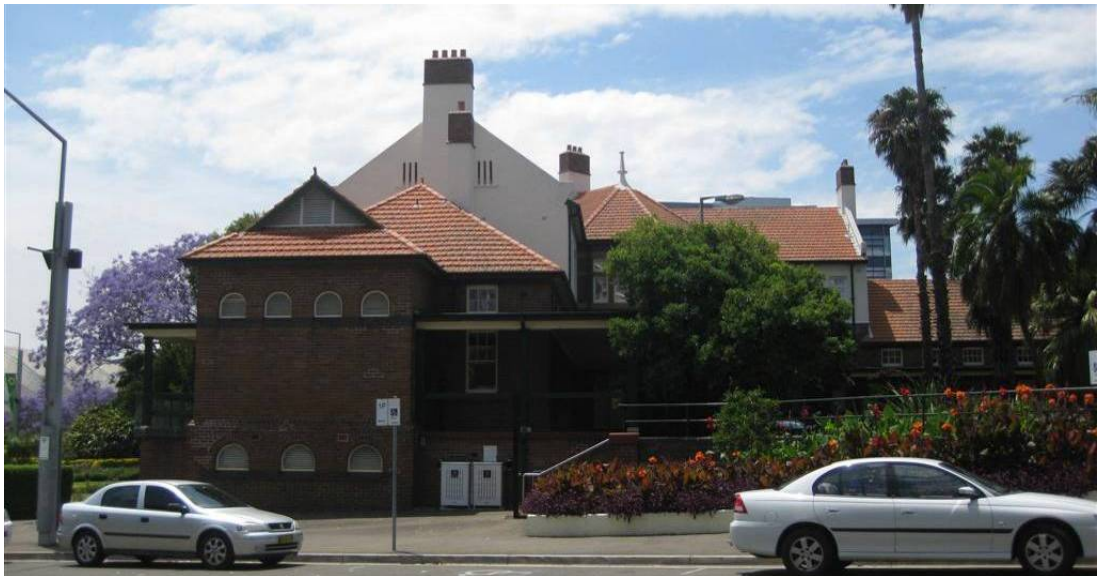
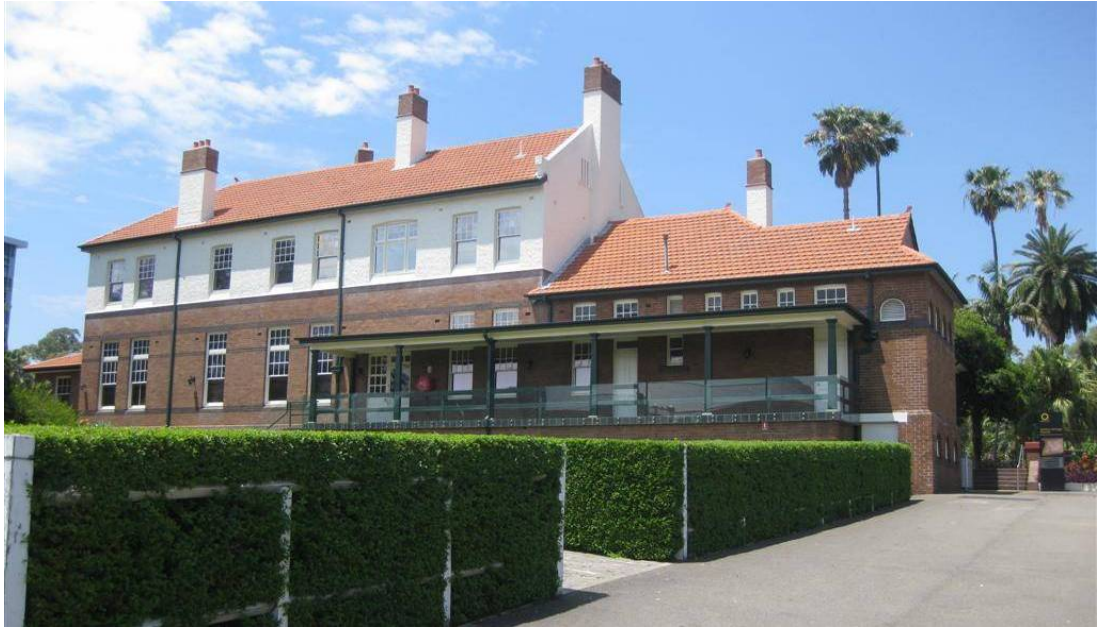
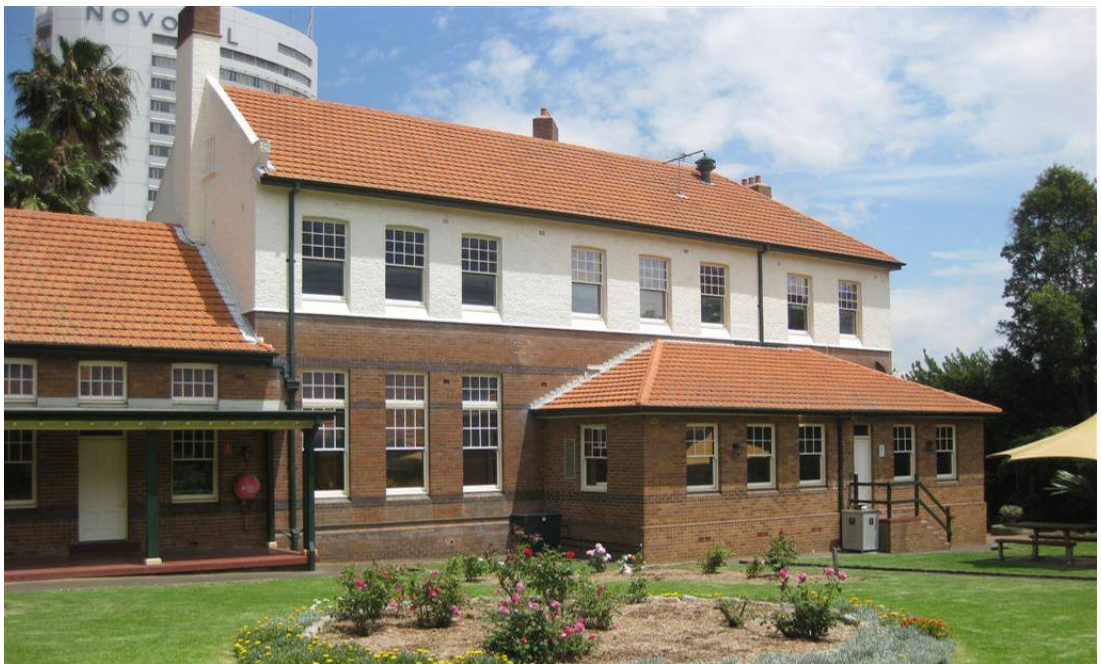
Externally, Building A looks very similar to as it was constructed in 1913, with face brick walls in two different colour bricks, sandstone banding and roughcast render for the first floor. The roof is terracotta tiles with hipped gables for the roof over the single storey sections and gables with chimneys over the first floor. The principal entry is still in the centre of the L-shaped plan, via a grand stair, flanked by verandahs, all facing the carriage loop and the palm grove. All windows are timber-framed, and mostly double-hung sash windows, with 8-12 paned upper sashes. At the ends of each wing are high-level arch-headed windows, as found in most buildings in the precinct, indicating lavatories and lockers. External doors are painted four-panel timber doors. At the main entry, all windows have sandstone borders and lintels.

Figure 52
Main entry

Figure 53
Western elevation

Figure 54
Northern elevation

Figure 55
Eastern elevation

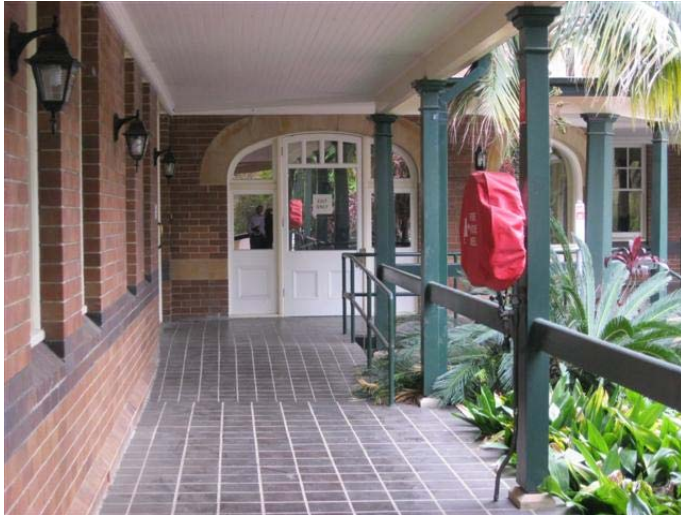
The front verandahs have been adapted to provide equitable access, involving provision of a ramp at one end and raising part of the verandah level to provide access to the internal floor level at grade. Both wings also have rear verandahs, overlooking the central lawn and the rose garden. The northern verandah has had glazed balustrades installed to meet building codes.

Figure 56
Front verandah. Note level changes to provide equitable access.

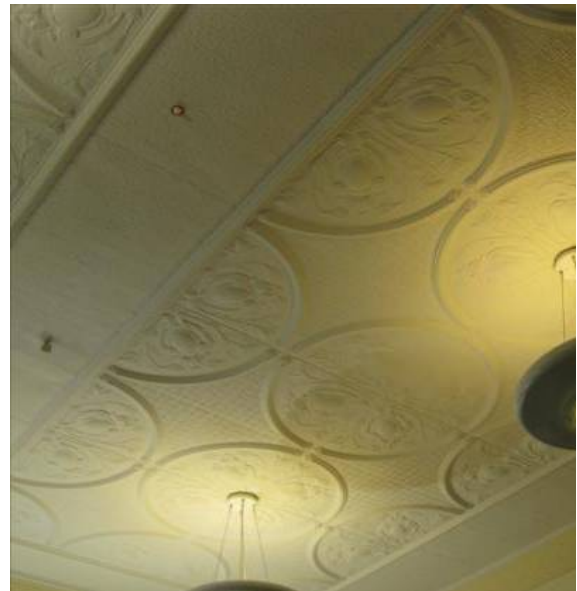
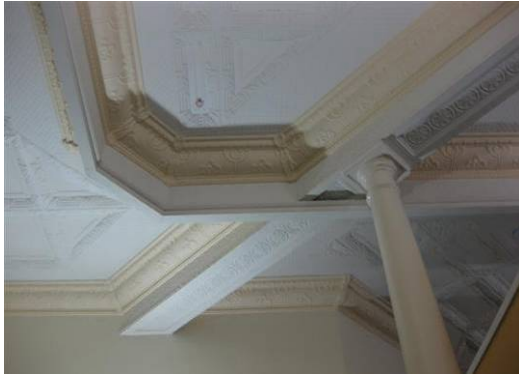
Internally, Building A has painted plastered walls and painted pressed metal ceilings. The ceiling is particularly elaborate in the main entry area. All joinery is painted, except the stair handrail and newel post.

Figure 60
Detail, pressed metal ceiling, ground floor

Figure 61
Pressed metal ceiling, lobby

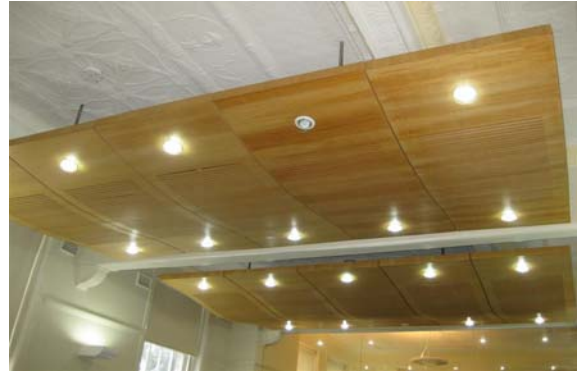
The layout of the ground floor reflects the alterations carried out during the early 1990s, with one large space in the southern wing (with retained, free-standing fireplaces) and offices on the remainder of the floor. A modern suspended timber ceiling was installed in one room on the northern side of the building, with the room being used as a board room. Most of these rooms have modern fitments suitable for office use. On the first floor, the original Board Room has been retained with its marble fireplace and timber casement windows in the bay window overlooking the palm grove. As in the other buildings in the precinct, all bathrooms and toilets have reproduction Federation period tiles and details.

Figure 62
Modern timber ceiling, ground floor board room

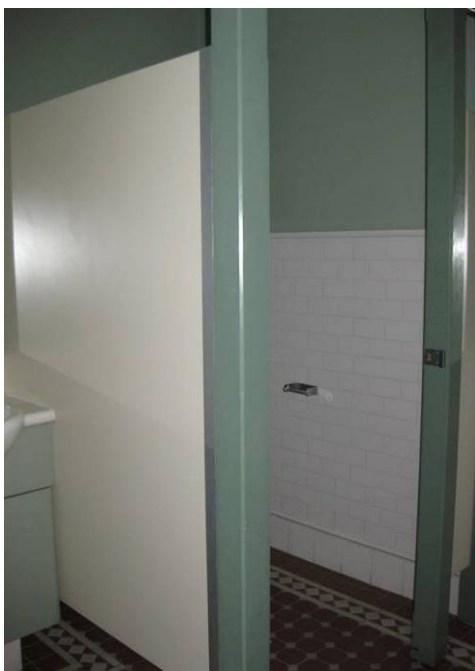
Figure 66
Typical bathroom finishes

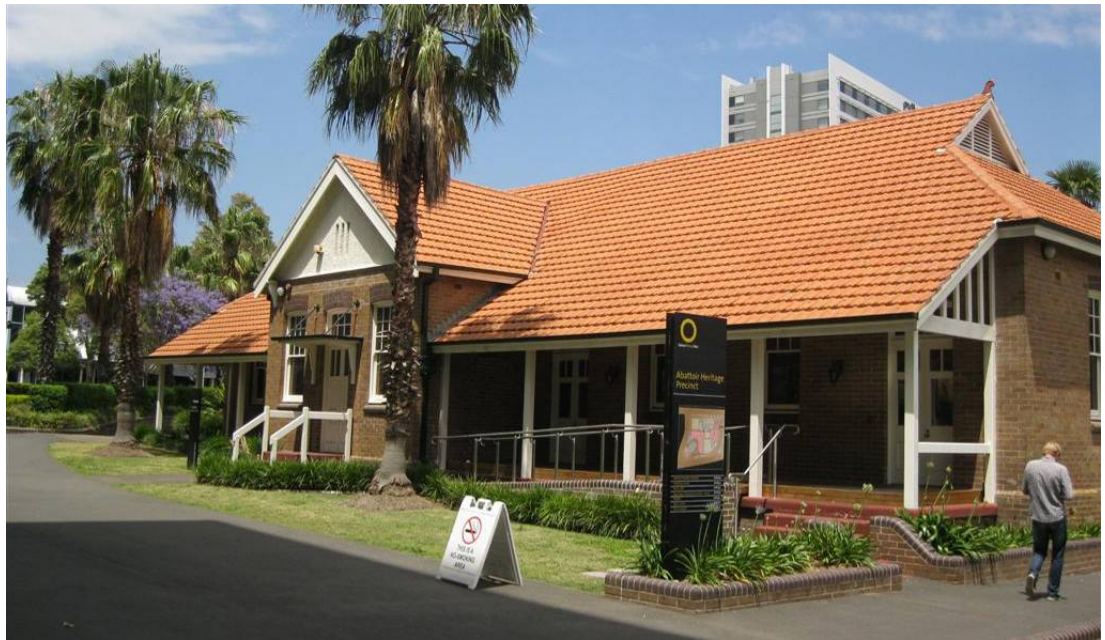
Externally, the building is constructed in face brick, with a terracotta tiled roof. The principal entrance was in the centre of the eastern façade, under a projecting gable between two verandahs, with roughcast render in the gable. The timber-framed verandahs have exposed rafters and boarded timber ceilings.

Figure 70
Eastern elevation of Building B

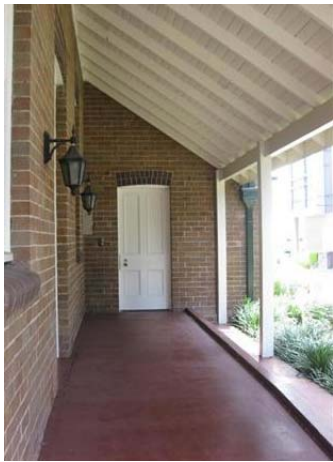
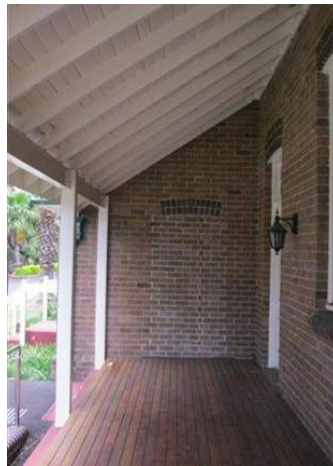
Both the two front verandahs have had alterations to provide equitable access: the southern verandah has had a coloured concrete ramp (to match the existing verandah) constructed within the width of the verandah to provide access to floor level; the northern verandah has had a recent timber floor at ground level constructed with a new brick-edged ramp constructed externally

Figure 73
South eastern verandah

Figure 74
North eastern verandah

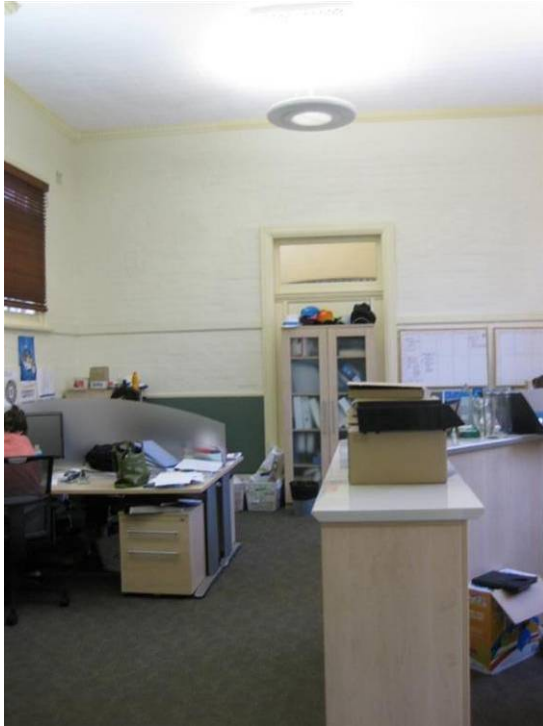
Internally, the buildings have a combination of painted face brick and painted plastered walls, with pressed metal ceilings and cornices. The floors are carpeted. Kitchens and bathrooms feature reproduction Federation period tiles and finishes. While it has been removed, there is still evidence of the location of the former kitchen fireplace.

This building is in very good condition.

Figure 76
Interior, Building B

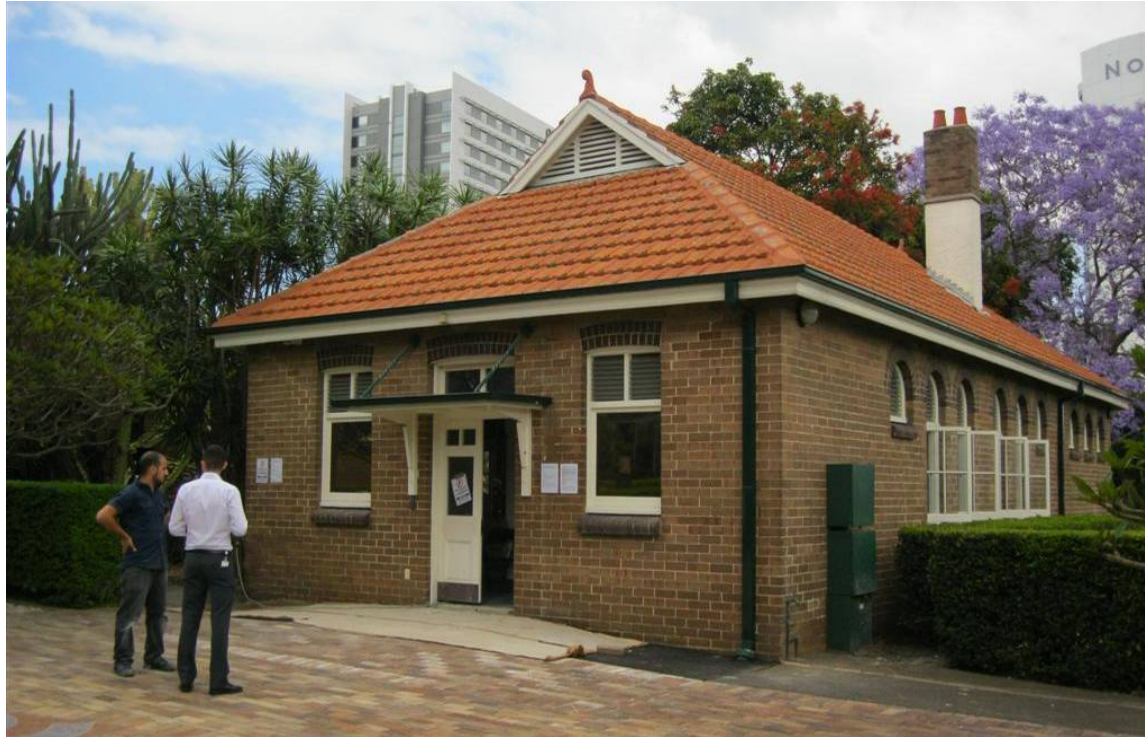
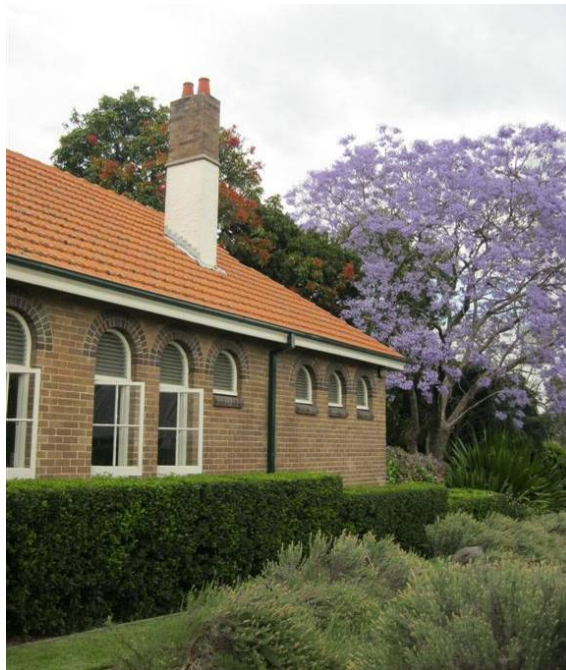
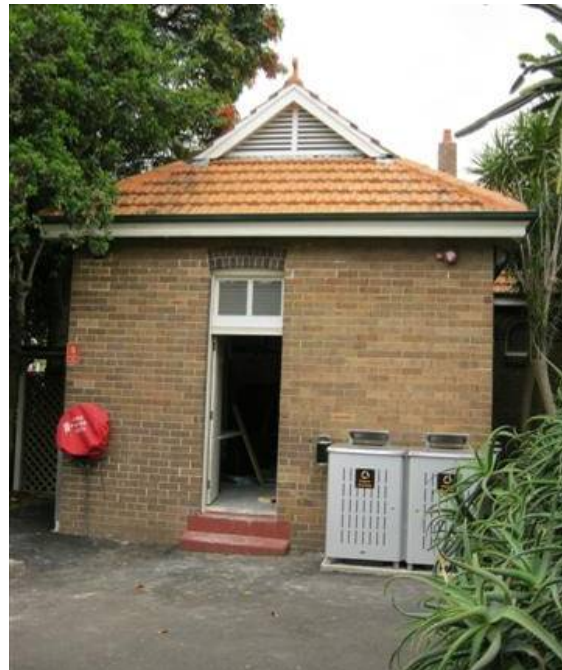
This building is in very good condition.

Figure 82
Eastern façade of Building C

Figure 83
Northern façade

Figure 84
Southern façade near Building B and succulent garden

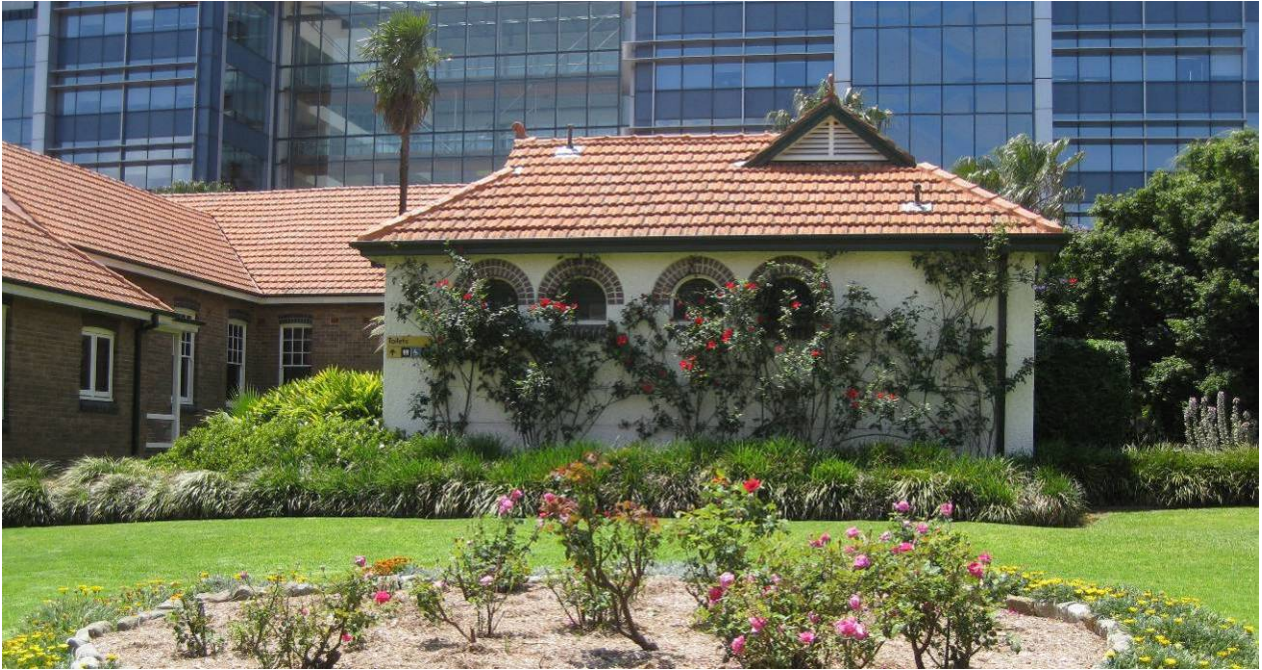
Figure 90
Western elevation of Building D, showing roughcast render and high-level brick-edged windows

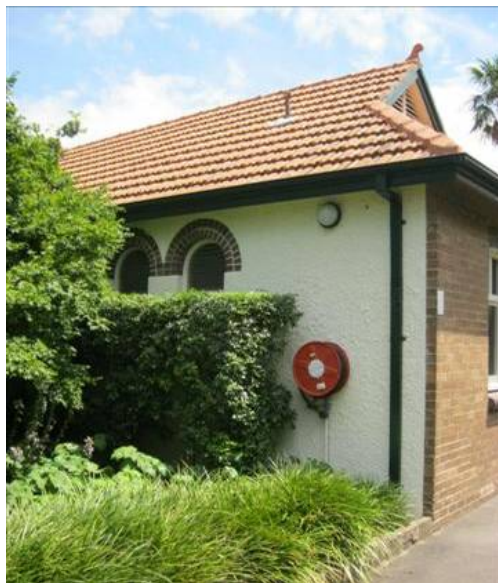
Figure 91
Southern wall, showing detail of roughcast render and brick arched openings

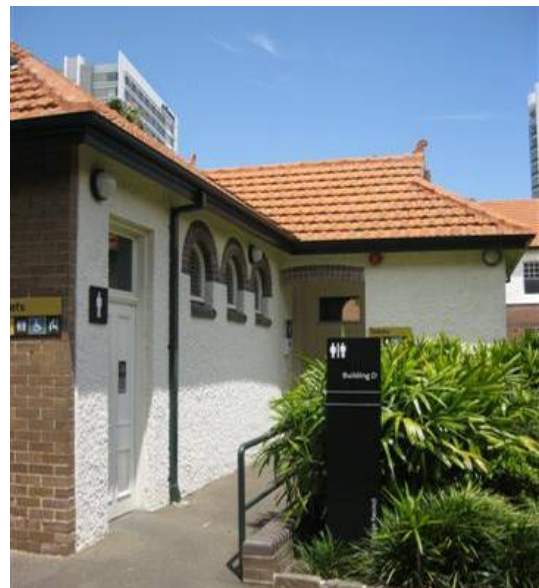
Figure 92
Northern wall, with ramp to accessible and ladies toilets

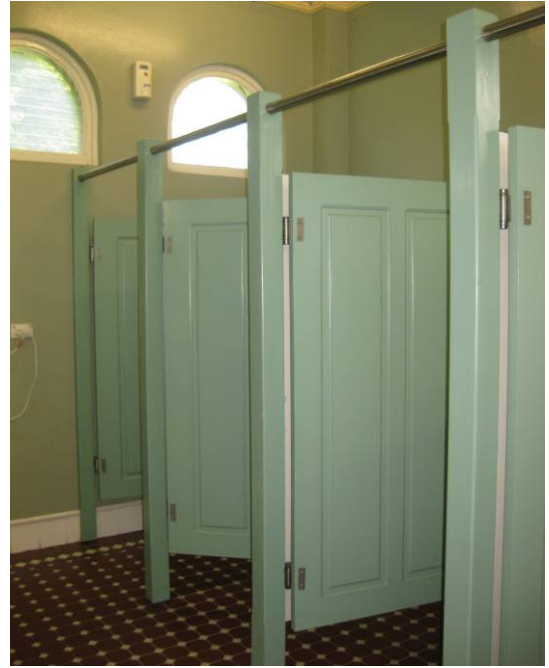
This building is in very good condition.

Figure 94
Interior of Building D, showing modern reproduction fitting and finishes

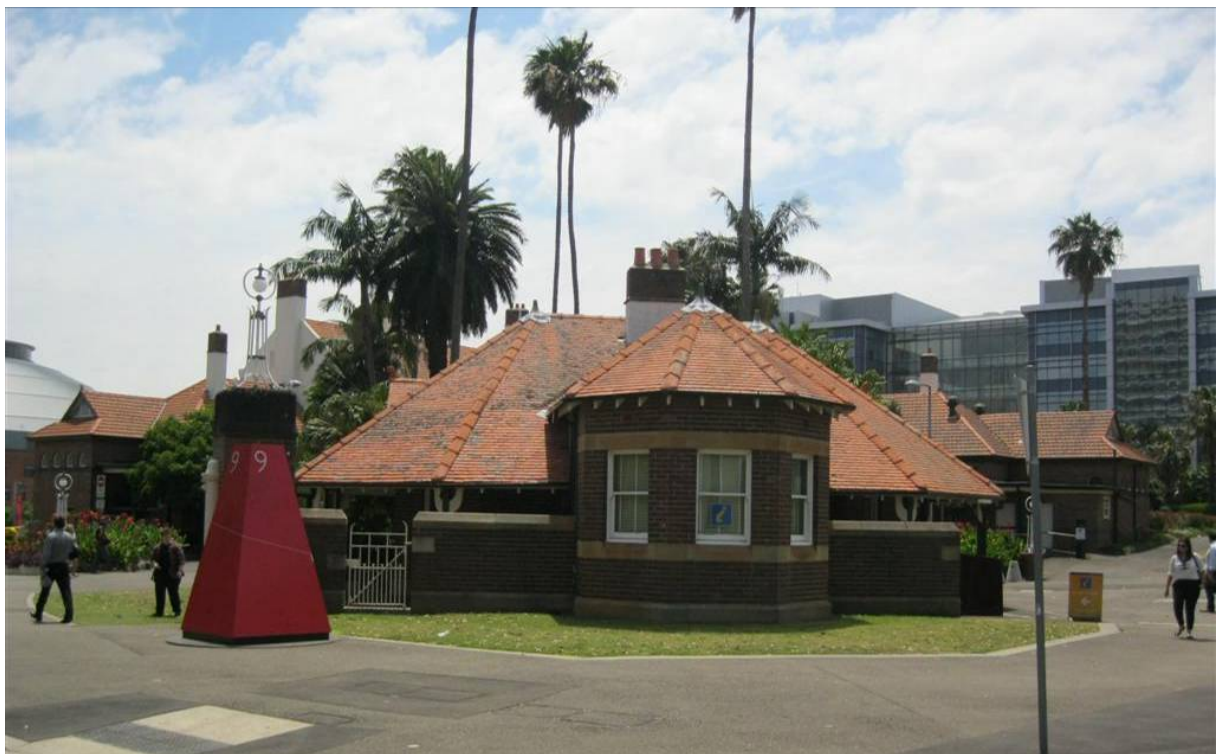
Figure 98
Gatehouse, Building E

This building is in very good condition.

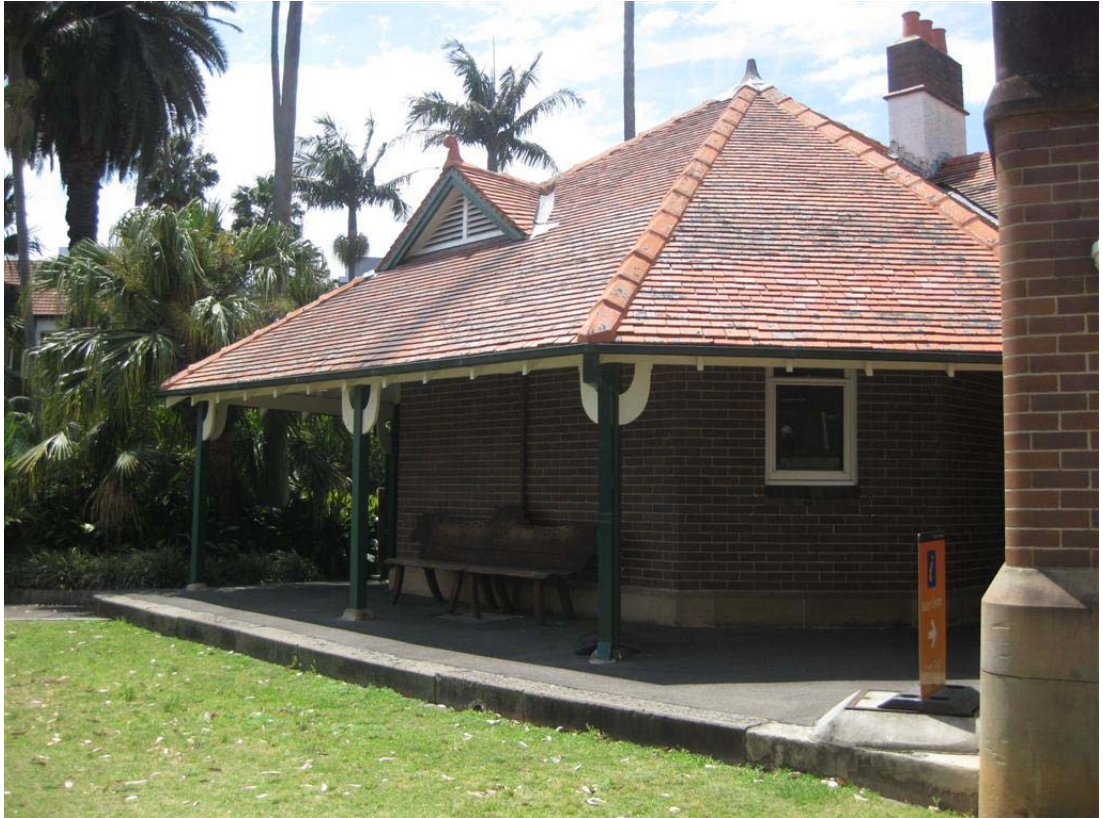
Figure 99
North verandah, Gatehouse, Building E

The northern verandah which was noted as being enclosed in 2003 (and evident in 1960s aerial photos) has since been reopened.

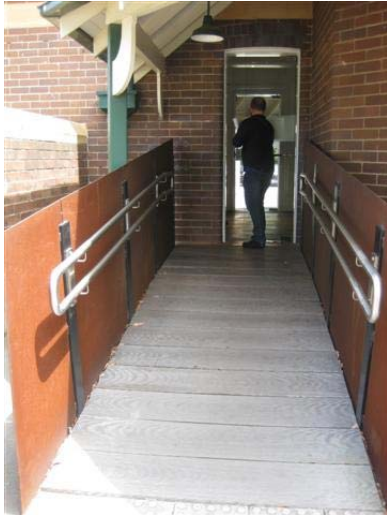
In recent years, a modern steel ramp into the southern door has been provided for equitable access.

Figure 102
Access ramp

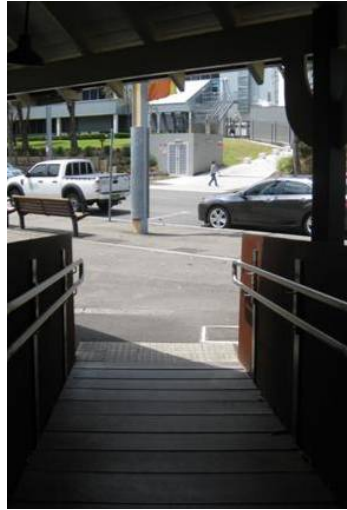
Figure 103
Access ramp, looking out

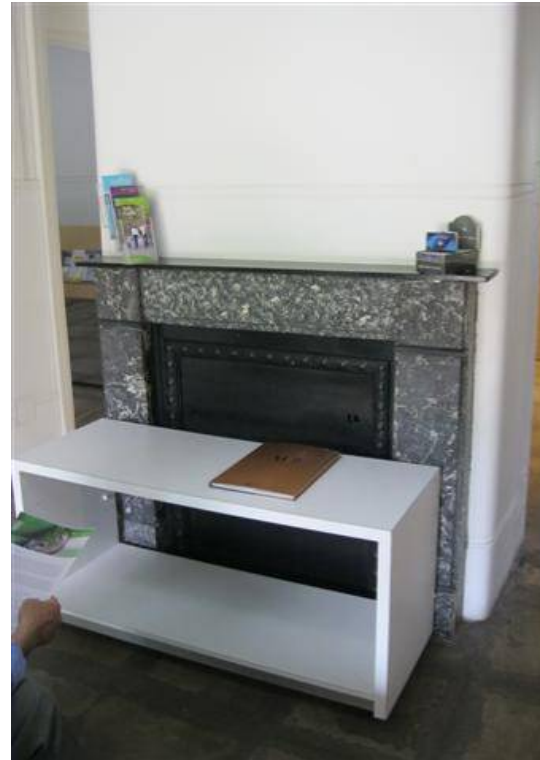
Figure 106
Marble fireplace

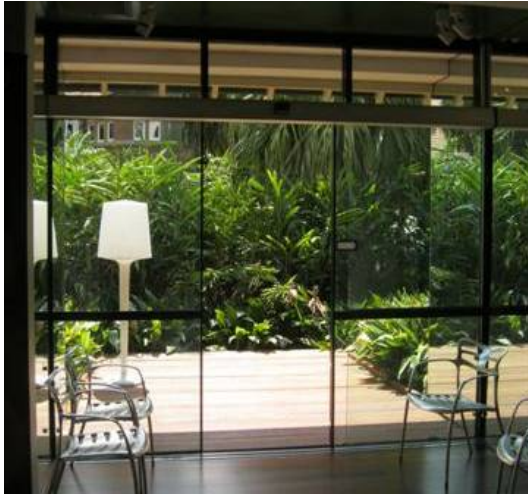
Figure 107
Glazed opening in 1950s northern extension

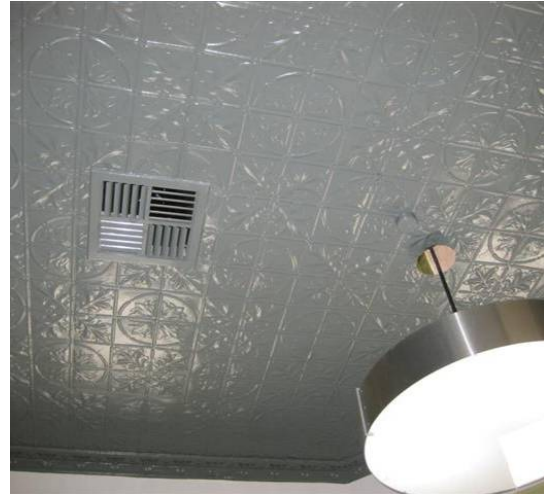
Figure 108
Pressed metal ceiling

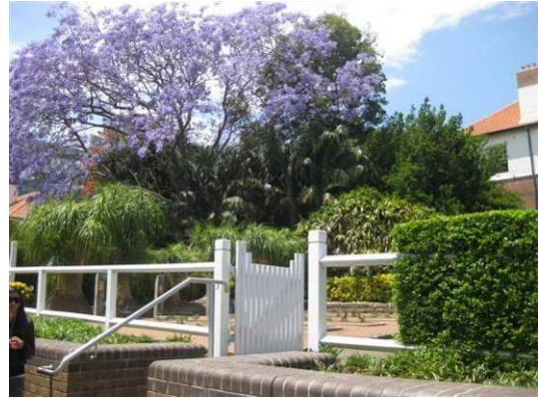
Figure 117
Timber post and rail fences along northern border of site.
