ABATTOIR HERITAGE PRECINCT SYDNEY OLYMPIC PARK

CONSERVATION MANAGEMENT PLAN

Report No. 13012

September 2013

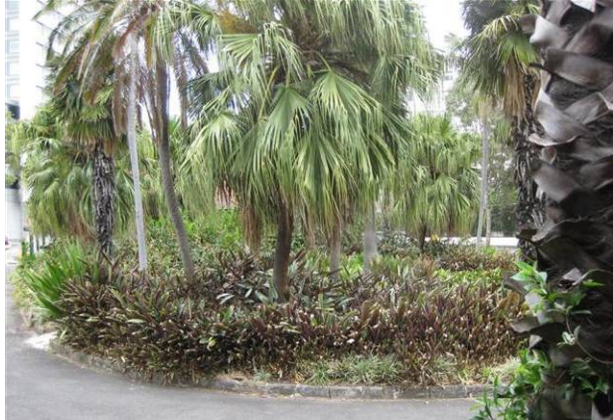
7.8 LANDSCAPE	<p>Series of designed gardens between buildings, incorporating areas of lawn, garden beds, paths, mature trees and other landscape elements.</p> <p>Much of the layout/configuration is original or based on the original, though some elements (such as the paved area adjacent to Building C) are modern.</p>	HIGH / MEDIUM	4	<p>Maintain landscaping</p> <p>Replace senescent trees with advanced plants of the same species.</p>

<p>Figure 152 Palm grove, between Building A and E</p>

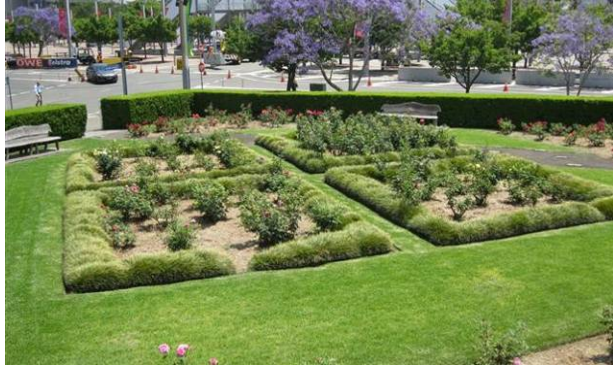
<p>Figure 153 Rosegarden, north of Building A</p>

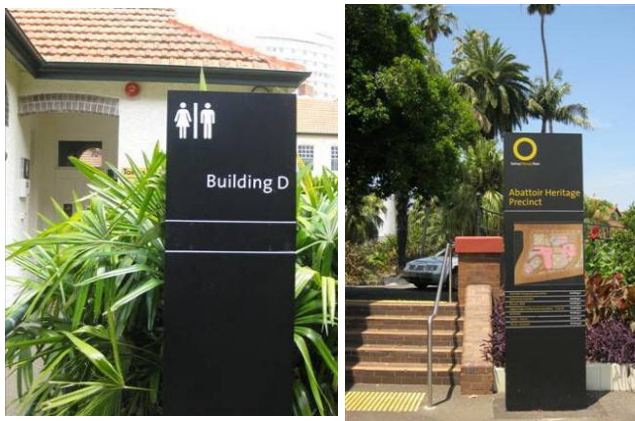
7.9 EXTERNAL SIGNAGE	Modern signage, based on SOPA guidelines	LITTLE / NEUTRAL	4	Minimise fixings to historic fabric

<p>Figure 154 Typical Building Identification sign, Building D, Precinct sign</p>

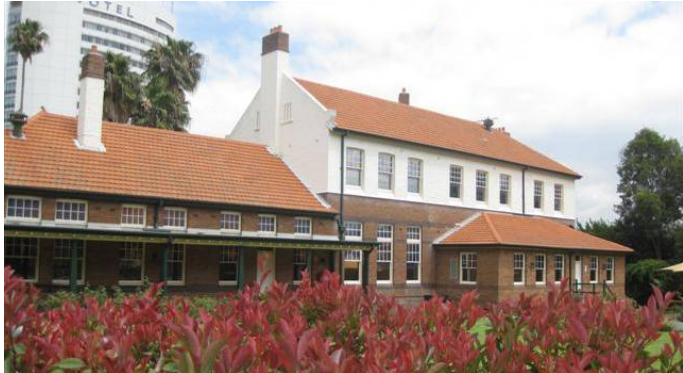
<p>Figure 155 Building A</p>	<p>Terracotta tiles in a Marseilles profile, with terracotta ridge cappings and finials, dating from the late 20th century.</p> <p>Painted metal gutters and downpipes, dating from the late 20th century.</p> <p>The roofs are dominant elements of the buildings, typical of buildings of the Federation period, particularly Building A, B and E.</p>	<p>Terracotta tiles and associated elements: HIGH/MEDIUM</p> <p>Roof plumbing: HIGH/MEDIUM</p>	<p>Terracotta tiles and associated elements: 5</p> <p>Roof plumbing: 4</p>	<p>Monitor condition of roof and plumbing.</p> <p>Patch, replace and repair as necessary to match existing, to protect significant internal fabric.</p>
<p>7.11 CHIMNEYS</p>

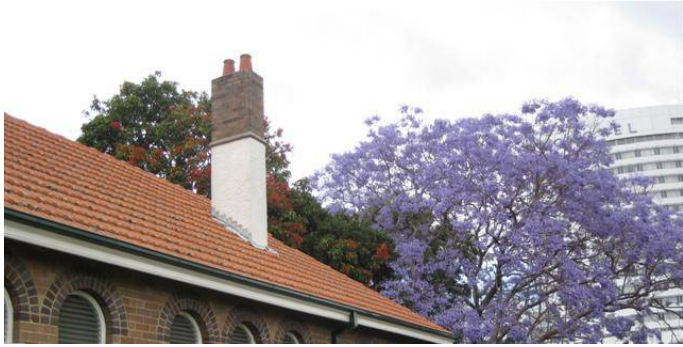
<p>Figure 156 Building C</p>	<p>Face brick and roughcast render chimneys on Buildings A, C and E, with terracotta chimney pots.</p> <p>Mostly dating from 1913-1918, though some may have been reconstructed during the 1980s. Chimney pots date from 1980s. Not all have extant internal fireplaces.</p>	<p>HIGH/MEDIUM</p>	<p>4</p>	<p>Investigate seismic stability and carry out stabilising works if required.</p> <p>Maintain condition.</p> <p>Functionality of chimneys is not essential, but retention is required.</p>

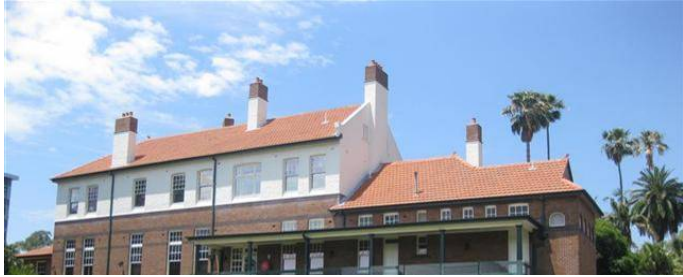
<p>Figure 157 Building A</p>	<p>Roughcast render parapets on Building A only.</p> <p>Dating from 1913.</p>	<p>HIGH/MEDIUM</p>	<p>4</p>	<p>Investigate seismic stability and carry out stabilising works if required.</p> <p>Maintain condition.</p>

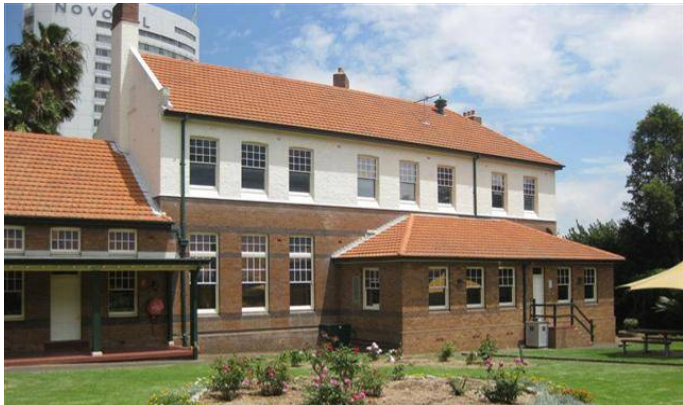
<p>Figure 158 Building A</p>	<p>Face brick work, roughcast render, some decorative sandstone and polychrome brick banding.</p> <p>Mostly dating from 1913-1918, though some walls of Building D were reconstructed during the 1980s.</p>	HIGH/MEDIUM	4	<p>Minimise fixings to external walls</p> <p>Monitor condition of brickwork and pointing.</p> <p>Always use soft lime-based mortars for repointing.</p> <p>Repaint roughcast render as required.</p> <p>Do not apply paint or roughcast render to face brick walls.</p>
<p>7.14 WINDOWS</p>

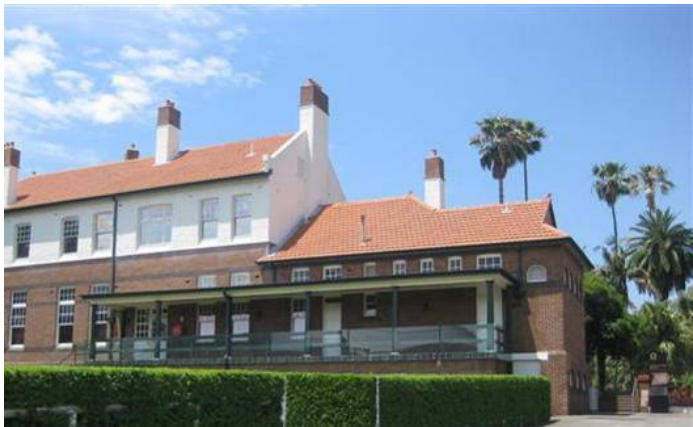
<p>Figure 159 Building A</p>	<p>Mostly timber-framed double-hung sash windows. Also casement windows (Building C), and high-level arched windows with fixed glazing or glazed louvres. Multi-pane sashes in double-hung windows in Building A</p> <p>Mostly dating from 1913-1918, though some are likely to have been replaced or reconstructed during the 1980s.</p>	HIGH/MEDIUM	4	<p>Maintain condition by regular painting.</p> <p>Do not paint closed.</p> <p>Some windows have an optical film applied. Remove during future maintenance</p>

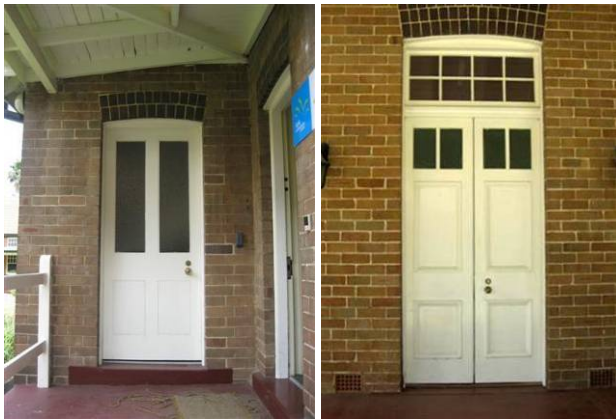
<p>Figure 160 Typical external doors, Building B</p>	<p>Panelled timber doors, either French doors or single leaf, some with glazed panels and fixed multi-pane fanlights.</p> <p>Mostly dating from 1913-1918, though some are likely to have been replaced or reconstructed during the 1980s.</p>	HIGH/MEDIUM	4	<p>Maintain condition by regular painting.</p> <p>Do not paint closed.</p> <p>Some glazed panels have an optical film applied. Remove during future maintenance</p>

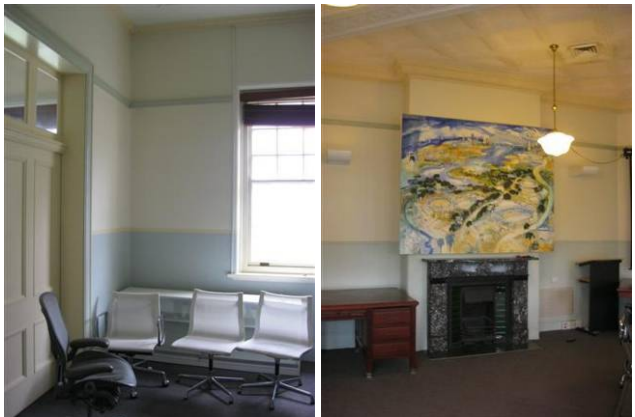
<p data-bbox="157 1627 593 1690">Figure 163 Internal walls, Building A</p>	<p data-bbox="860 1218 1498 1407">Internal walls are generally painted plaster masonry walls, with tiled surfaces in bathrooms etc. Some walls in Buildings B, C and D are painted face brick. Mostly dating from 1913-1918, though some internal walls relate to changes during the 1980s.</p>	<p data-bbox="1558 1218 1736 1260">HIGH/MEDIUM</p>	<p data-bbox="1825 1218 1855 1260">4</p>	<p data-bbox="2033 1218 2745 1522">Maintain condition by regular painting. Investigate early / original colour schemes and consider painting in these colours during future refurbishment works. Minimise openings in existing walls for revised internal configurations. During future refurbishment works, investigate opportunities to demolish late 20th century walls and/or reconstruct walls in original locations.</p>

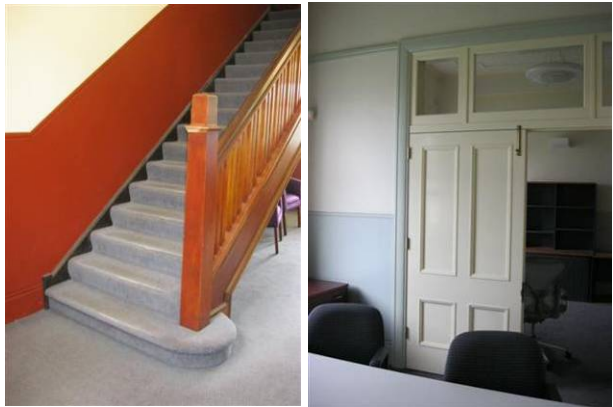
<p>Figure 164 Joinery, Building A</p>	<p>All joinery is painted, except the stair in Building A, which is stained with a clear finish.</p> <p>Mostly dating from 1913-1918, though there is some modern reproduction joinery associated with new internal walls and openings dating from the 1980s.</p>	<p>Original joinery: HIGH / MEDIUM</p> <p>1980s joinery: LITTLE / NEUTRAL</p>	4	<p>Maintain condition by regular painting.</p> <p>Investigate early / original colour schemes and consider painting in these colours during future refurbishment works.</p>
<p>7.19 INTERNAL DOORS</p>

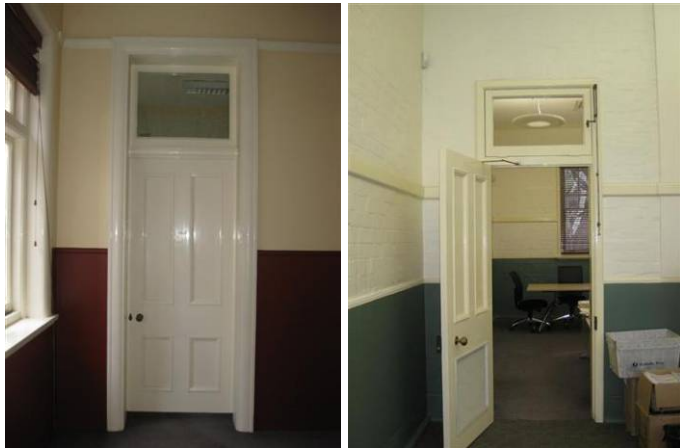
<p>Figure 165 Typical internal doors, Building A & Building B</p>	<p>Most internal doors are timber panelled doors with a painted finish. Some internal doors are modern aluminium framed and glazed.</p> <p>Mostly dating from 1913-1918, though there is some modern reproduction joinery and modern glazed doors associated with new internal walls and openings dating from the 1980s.</p>	<p>Original internal doors: HIGH / MEDIUM</p> <p>1980s internal doors: LITTLE / NEUTRAL</p>	4	<p>Maintain condition by regular painting.</p> <p>Investigate early / original colour schemes and consider painting in these colours during future refurbishment works.</p> <p>Consider removal of modern doors in later walls during future refurbishment works.</p>

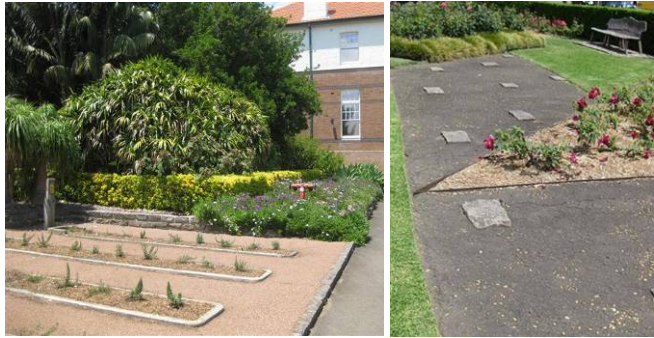
Figure 166
Interpretation, north of Building A

<p>Various interpretive elements, including seating with cow motifs, mosaic panels, relocated cattle troughs and sheep run</p>	LITTLE / NEUTRAL INTRUSIVE	3-4	Develop a comprehensive Interpretation Strategy & Plan for Precinct Implement interpretation on site and digitally
